## CODE 45

### OXYGEN SENSOR CIRCUIT (RICH EXHAUST INDICATED) 2.8L "P" SERIES (PORT)

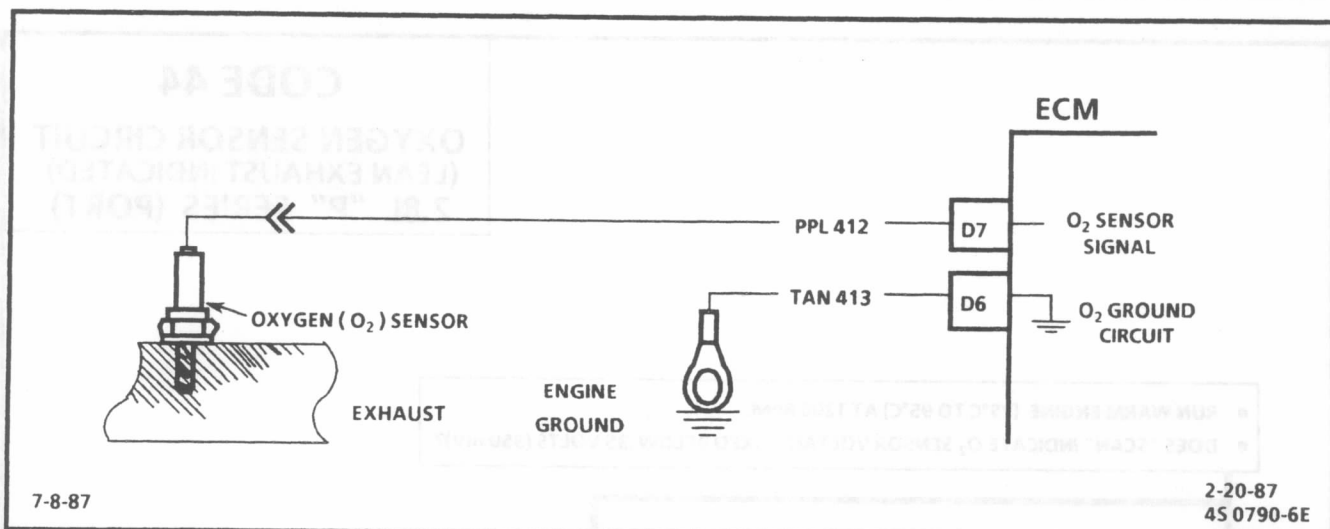
#### Circuit Description:

The ECM supplies a voltage of about .45 volt between terminals "D6" and "D7". (If measured with a 10 megohm digital voltmeter, this may read as low as .32 volt.) The O<sub>2</sub> sensor varies the voltage within a range of about 1 volt if the exhaust is rich, down through about .10 volt if exhaust is lean.

The sensor is like an open circuit and produces no voltage when it is below about 315°C (600°F). An open sensor circuit or cold sensor causes "Open Loop" operation.

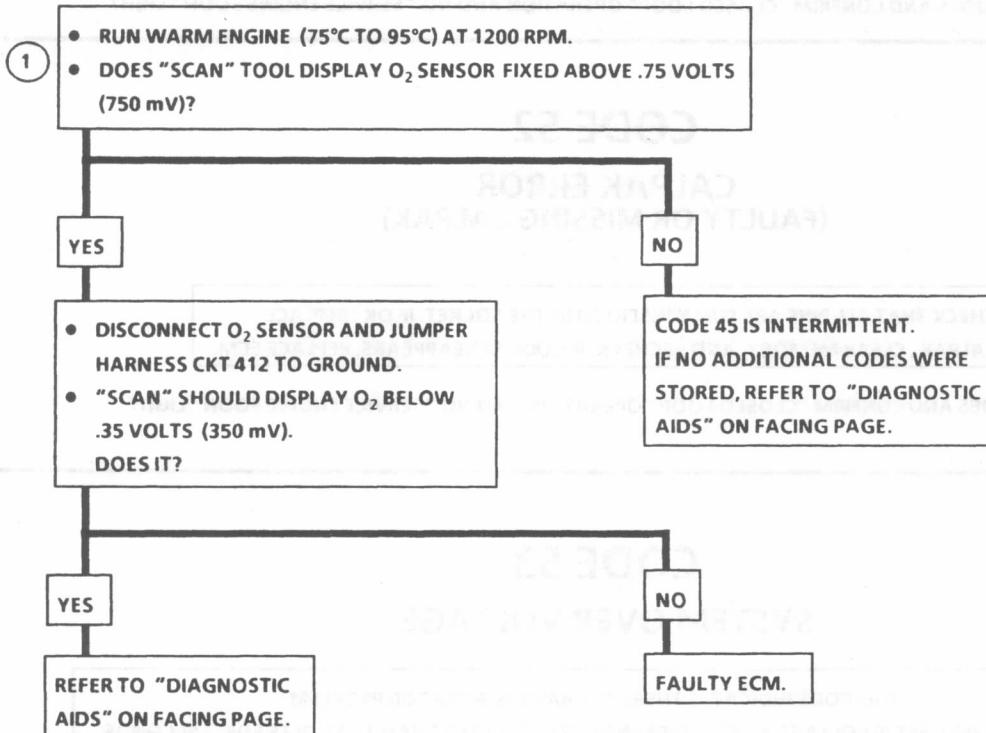
**CODE 45**  
**OXYGEN SENSOR CIRCUIT**  
**(RICH EXHAUST INDICATED)**  
**2.8L "P" SERIES (PORT)**

**Test Description:** Numbers below refer to circled numbers on the diagnostic chart.

- Code 45 is set when the O<sub>2</sub> sensor signal voltage or CKT 412
  - Remains above .7 volt for 50 seconds; and in "Closed Loop"
  - Engine time after start is 1 minute or more
  - Throttle angle greater than 2% (about .2 volt above idle voltage)

CLEAR CODES AND CONFIRM "CLOSED LOOP" OPERATION AND NO "SERVICE ENGINE SOON" LIGHT.

Using the "Scan", observe the block learn values at different rpm conditions to determine when the Code 45 may have been set. If the conditions for Code 45 exists, The block learn values will be around 115.

- Fuel pressure** System will go rich if pressure is too high. The ECM can compensate for some increase. However, if it gets too high, a Code 45 may be set. See fuel system diagnosis CHART A-7.
- For rich injector** Perform injector balance test CHART C-2A.
- For leaking injector** See CHART A-7.
- For fuel contaminated oil
