Fiero Stereo Systems

Northern Illinois Fiero Enthusiasts

19 May 2012

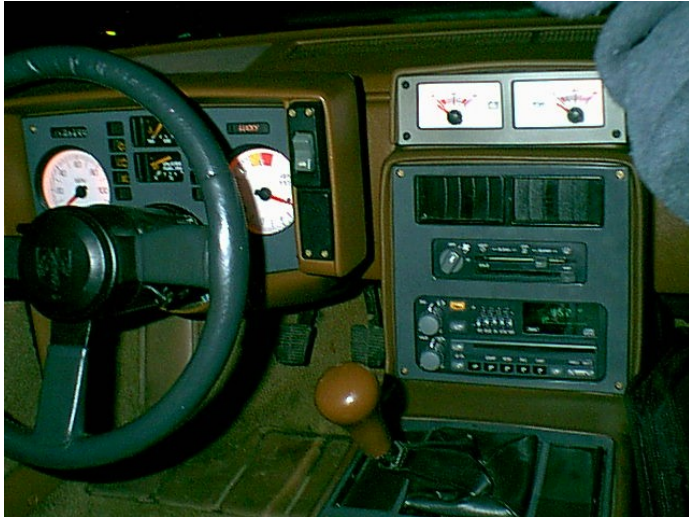
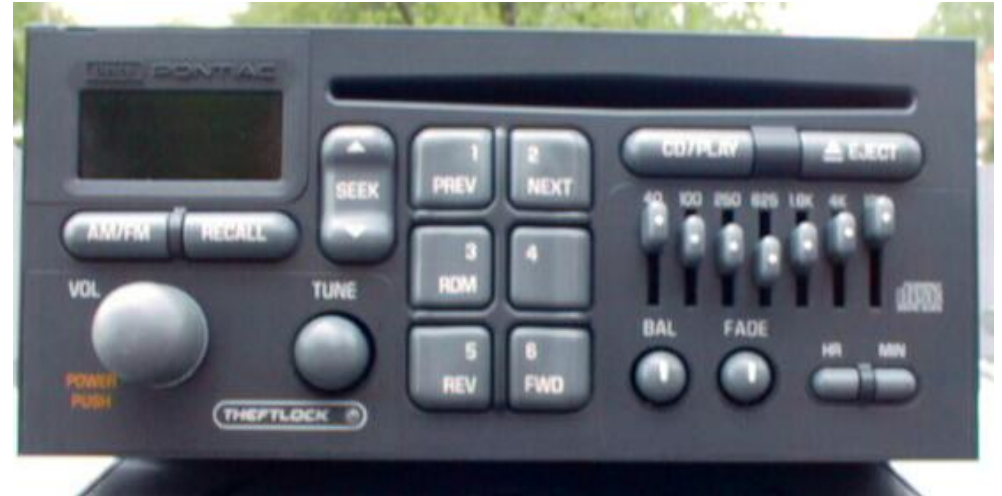
Newer GM Head Units

Adding 1989 or newer GM Radio

- Adapter or part of radio harness removed from donor car.
- Adapters run about \$20.
- Also need an antenna adapter due to size difference.
- Late 1990's and newer might also have "Theft-Loc" feature which requires a code to unlock.
- 2002 and newer uses data bus input. Adapter boxes to use these run \$150 to \$250.

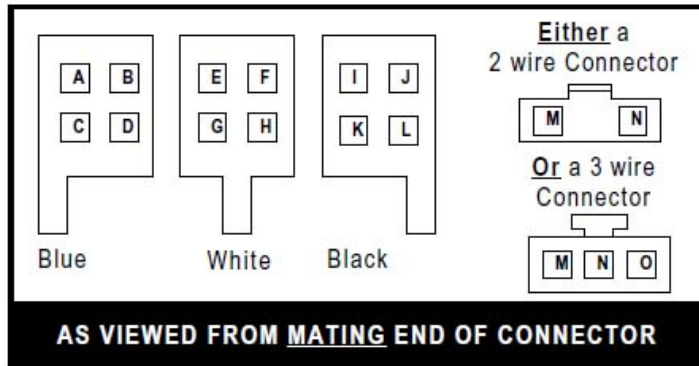
Up To 1989-1990

Wiring Differences

Pin	What It Is	Typical GM Factory In Dash Wire Color	Typical New Radio Equivalent Wire Color
A	Right Rear Spkr (-)	Light Blue	Purple w/ Black Stripe
B	Left Rear Spkr (-)	Yellow	Green w/ Black Stripe
C	Right Rear Spkr (+)	Dark Blue	Purple
D	Left Rear Spkr (+)	Brown	Green
E	Left Front Spkr (+)	Tan	White
F	Right Front Spkr (+)	Light Green	Gray
G	Left Front Spkr (-)	Light Gray	White w/ Black Stripe
H	Right Front Spkr (-)	Dark Green	Gray w/ Black Stripe
I	Power Antenna Turn On	Pink (if available)	Blue
J	+12 Volt Ignition Wire	Yellow	Red
K	Headlight Dimmer Wire	Gray	Orange (if available)
L	Ground Wire	Black	Black
M	+12 Volt Battery Wire	Orange	Yellow
N	Not Used		Not used

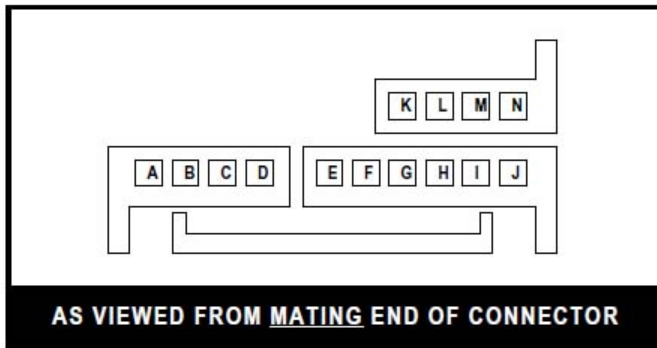
1989-1990 And Newer

Wiring Differences

Pin	What It Is	Typical GM Factory In Dash Wire Color	Typical New Radio Equivalent Wire Color
A	Left Front Spkr (-)	Light Gray	White w/ Black Stripe
B	Left Front Spkr (+)	Tan	White
C	Right Front Spkr (-)	Light Green	Gray w/ Black Stripe
D	Right Front Spkr (+)	Dark Green	Gray
E	Ground Wire	Black	Black
F	Not Used		
G	Headlight Dimmer Wire	Gray	Orange (if available)
H	Power Antenna Turn On	Pink (if available)	Blue
I	+12 Volt Ignition Wire	Yellow	Red
J	+12 Volt Battery Wire	Orange	Yellow
K	Right Rear Spkr (-)	Light Blue	Purple w/ Black Stripe
L	Right Rear Spkr (+)	Dark Blue	Purple
M	Left Rear Spkr (-)	Yellow	Green w/ Black Stripe
N	Left Rear Spkr (+)	Brown	Green

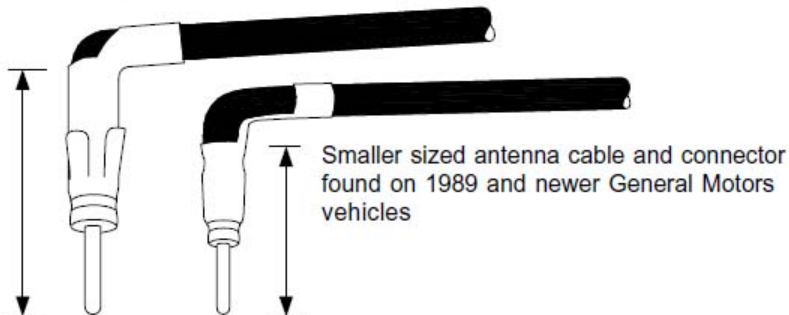
Standard sized antenna cable and connector

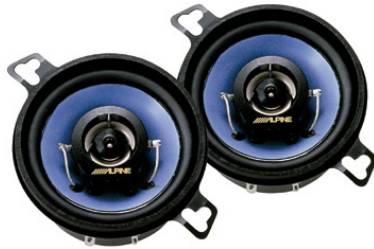
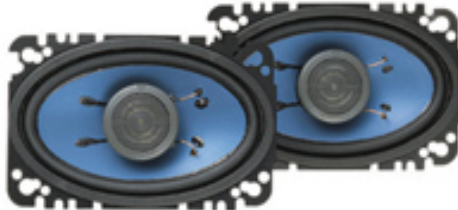
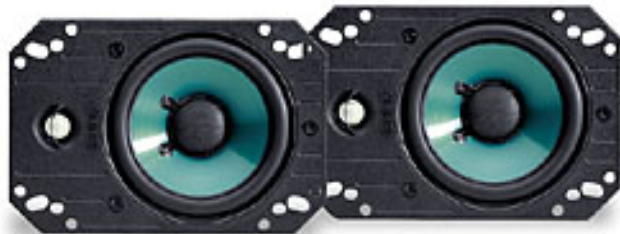
- Dash 4X10
- 84/85 Seats 3.5”
(2 pairs required)
- 86-88 Sail Panels 4X6
- Optional 4X6 Plates
(may require metal trimming)

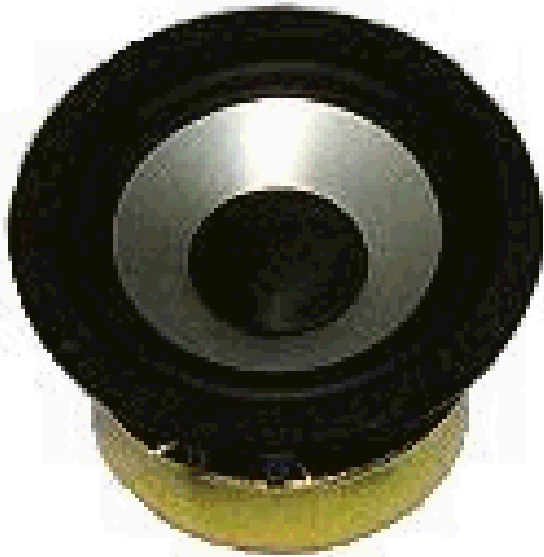
Factory Performance Sound

Rodney Dickman's Factory Sub
Replacement Speaker.

1986 thru 1988 "Performance
Sound" Option.

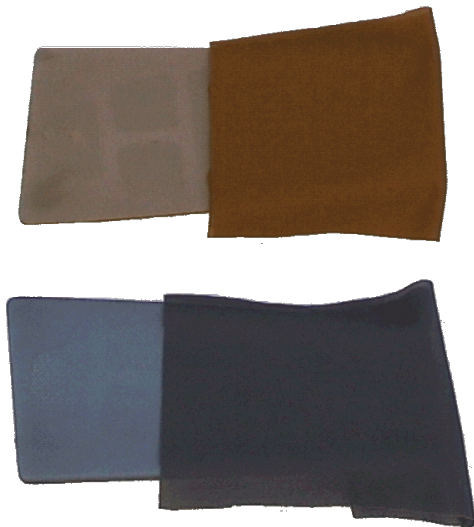
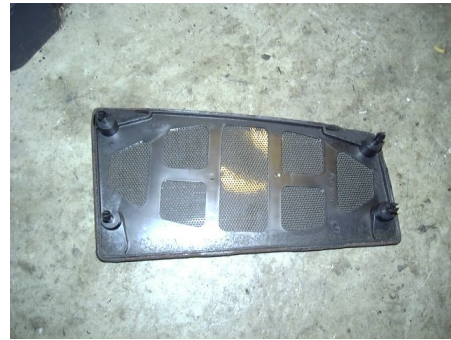
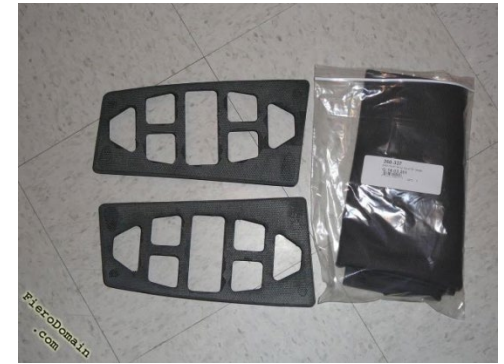
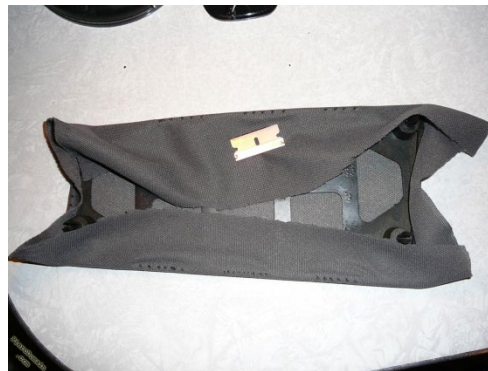
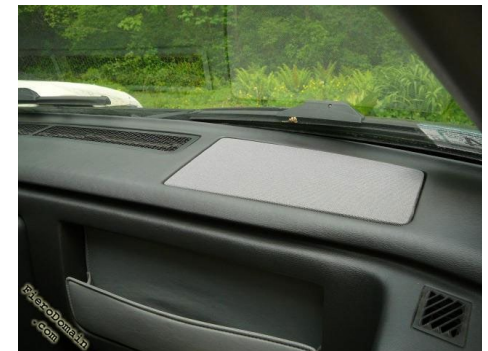
Grill cloth can be replaced as it fades over time.

Original Faded / New Replacement

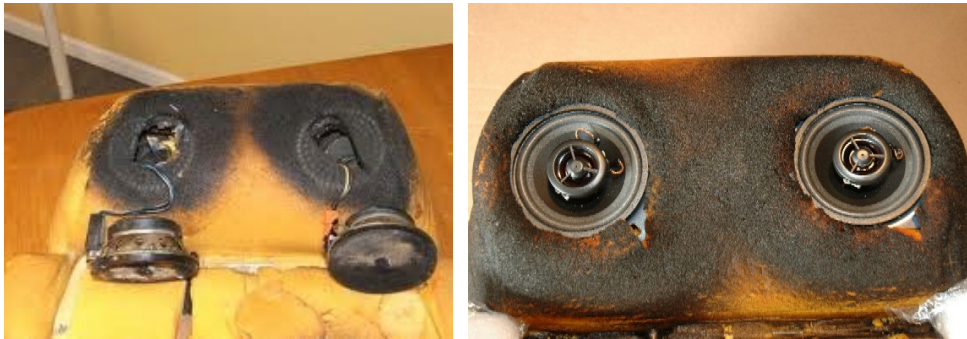
- Seat covers need to be removed to access headrest speakers.

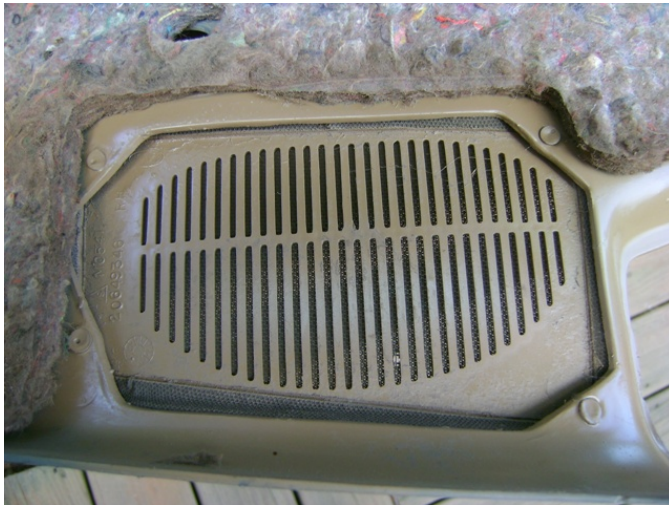
- Rear Sail Panel speakers on 1986 – 1988 Fiero's have grill "melted" into panel.
